Bond analysis of corroded reinforced concrete beams under monotonic and fatigue loads

Rania Al-Hammoud, Khaled Soudki *, Timothy H. Topper

Department of Civil Engineering, University of Waterloo, Waterloo, ON, Canada N2L 3G1

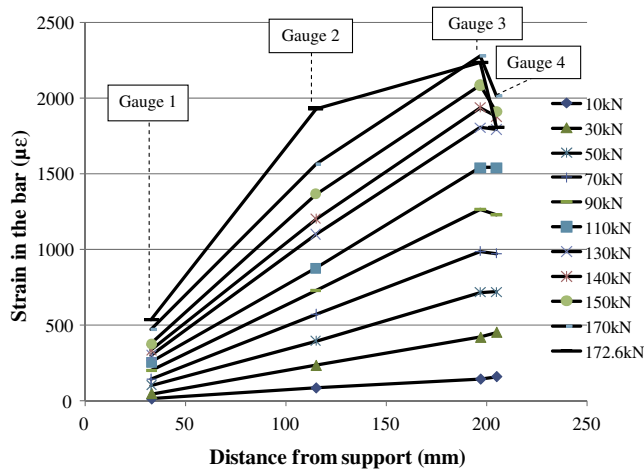
Fig. 5. Strain variation with load along the length of the bar for beam M-R-100-n.

Three strain gauges were mounted in one of the bars in each beam along the bonded length and a fourth gauge in the pocket. Fig. 5 shows the strain variation with load for beam M-R-100-n along the length of the bar starting from the support (0 mm). It is evident that no stress discontinuity has occurred although the bar was un-bonded beyond the pocket location. The increase in the tensile force in the beam beyond this point was taken by the CFRP strips that were added to the sides of the beam. Hence no increase in stress occurred beyond that point (pocket location) and the force in the bar remained constant. Before cracking, it is clear that the strain along the length of the bar in the anchorage zone (200 mm) is linear. As the load increased, cracks appeared in the beam at the anchorage zone level of the bar. These cracks caused a sudden local increase in the strain values of the strain gauges mounted nearest to the cracks. For beam M-R-100-n, the first crack occurred close to strain gauge 3 at a load of about 140 kN, and then at the maximum load (172.7 kN) a crack was observed close to strain gauge 2 accompanied by a sudden increase in gauge 2 strain value (Fig. 5). This strain pattern of sudden increases in strain readings close to cracks was similar for all the monotonic beams. The introduction of the FRP strips on the sides of the beams (away from the anchorage zone) removed the change in the nominal stress in the bar at the end of its un-bonded length; however, there are still stress discontinuities at cracks.

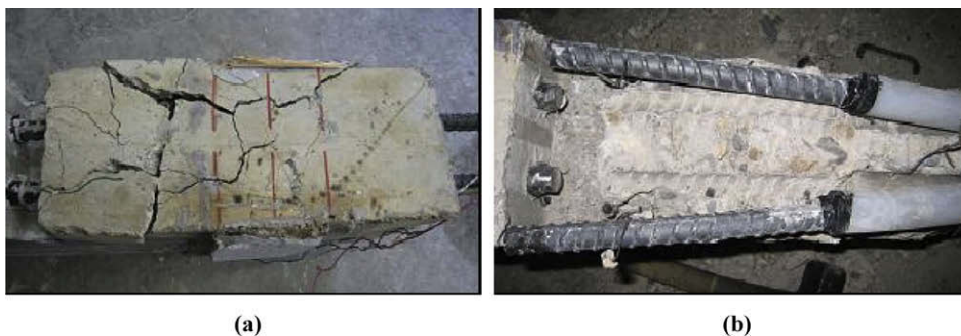
Fig. 10. (a) The cracks after failure in the bonded region of beam F80-U-n1 turned upside down. (b) Intact concrete in the top bar of the beam in beam F80-U-n2.

After failure of the beams, the failure surface was inspected. It was observed that the bottom concrete of the beam cracked into pieces (Fig. 10a). When these pieces were removed the concrete was found to be intact. The bars were then cut and removed from the beam to inspect the upper concrete to which the bar was held by the stirrups. It was found that the upper concrete between the lugs was partially crushed (Fig. 10b).

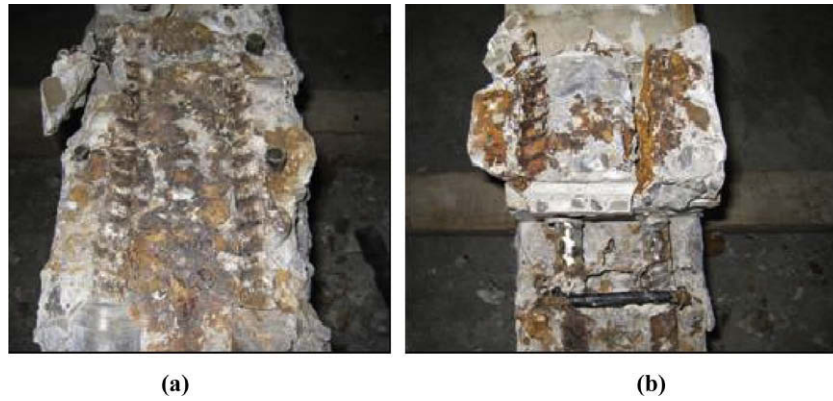
Fig. 11. Fatigue failure in beam F-U-43-I: (a) upper concrete above bar and (b) lower concrete below the bar.

The fatigue results for the corroded beams were close to the results that were reported by [23] (Table 1). The removal of the stress raiser in the bar did not have a large effect on the behaviour of these beams. During an examination of the contact surface at failure, it was noticed that the concrete in between the lugs was already partially crushed due to the rust product from the corrosion process (Fig. 11). This reduced the strength of the concrete keys and increased the rate of slip in the bar under repeated loading.

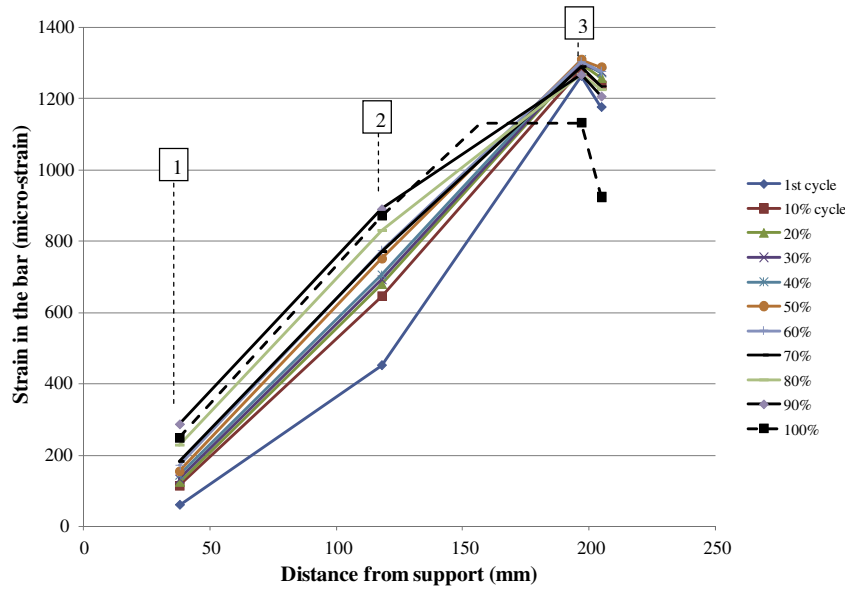
Fig. 13. Strain variation with respect to percentage of fatigue life along the distance of the bar for Beam F-U-70-n2.

The readings from the strain gauges mounted on the steel bar were plotted versus their locations on the bar for various percentages of the fatigue life of a beam. Fig. 13 shows the strain variation along the length of the steel bar for beam F-U-70-n2 starting from the support (0 mm). The strain increased linearly with distance

from the support. The last data point in each plot is the strain in the bar mounted at the pocket. It is clear from the strain readings that due to the introduction of the FRP strips on the sides of the beam there is no discontinuity in the strain along the bar between the bonded region and the un-bonded region (Fig. 15). The small variation in the readings of the strain gauges mounted at the pocket (un-bonded region) is probably due the inaccuracy in the FRP strip width, which will cause a slightly higher or lower strain value. The strain values increase with the increase in the number of cycles. As local cracks appear, the local strains show a sudden increase. At 100% of the fatigue life, a horizontal crack ran between the locations of strain gauges 2 and 3 as part of the concrete debonded along the bar between these two points (dashed line in Fig. 13). There was a reduction in the strain reading at point 3 that can probably be attributed to a reduction in the bar force as the central cracks opened, the neutral axis moved up, and the distance between the centroid of the concrete force and the steel bar increased.

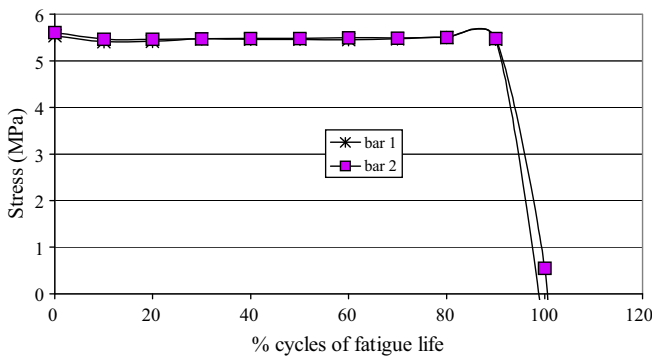
Fig. 14. Stress versus cycles for both bars in beam F-U-70-n1.

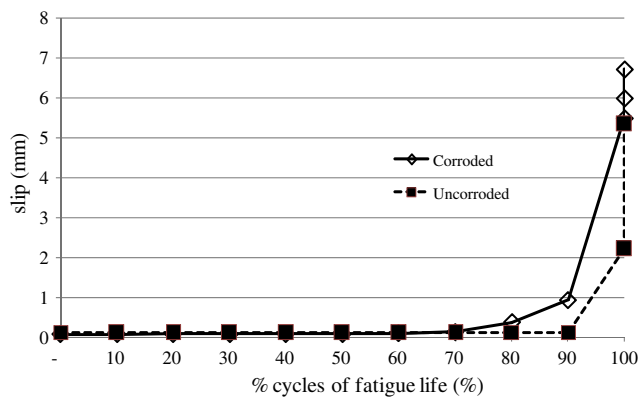
Fig. 15. Typical slip behaviour of the bars with respect to the number of cycles (corroded: beam F-U-43-I; uncorroded: beam F-U-70-n1).

Slip was measured as the relative movement between the steel bar and the concrete. The steel slip was measured using LVDT's that were mounted on the steel bar at the free end (end of beam) and the loaded end (in the pocket). The measured slip at the loaded and the free ends for bars 1 and 2 was almost the same. The slip remained almost constant as the number of cycles increased until failure when the slip increased suddenly (Fig. 15). In the control

uncorroded beams there was not much increase in slip with cycles until failure occurred. On the other hand, the corroded beams showed an increase in slip earlier in the fatigue life (Fig. 15).
