Study of the mechanical behavior of masonry repair lime-based mortars cured and exposed under different conditions

J. Lanas^a, R. Sirera^b, J.I. Alvarez^{b,*}

Abstract

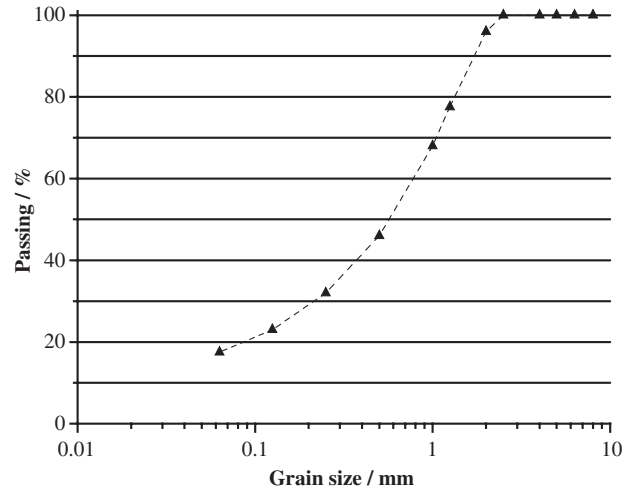
Fig. 2. Grain size distribution of the aggregate.

In this work, a pure limestone aggregate of angular edges with controlled granulometry was used. It was supplied by CTH Navarra (Navarra). Its chemical composition, X-ray diffractogram and grain size distribution are introduced in Table 1, Figs. 1 and 2, respectively.

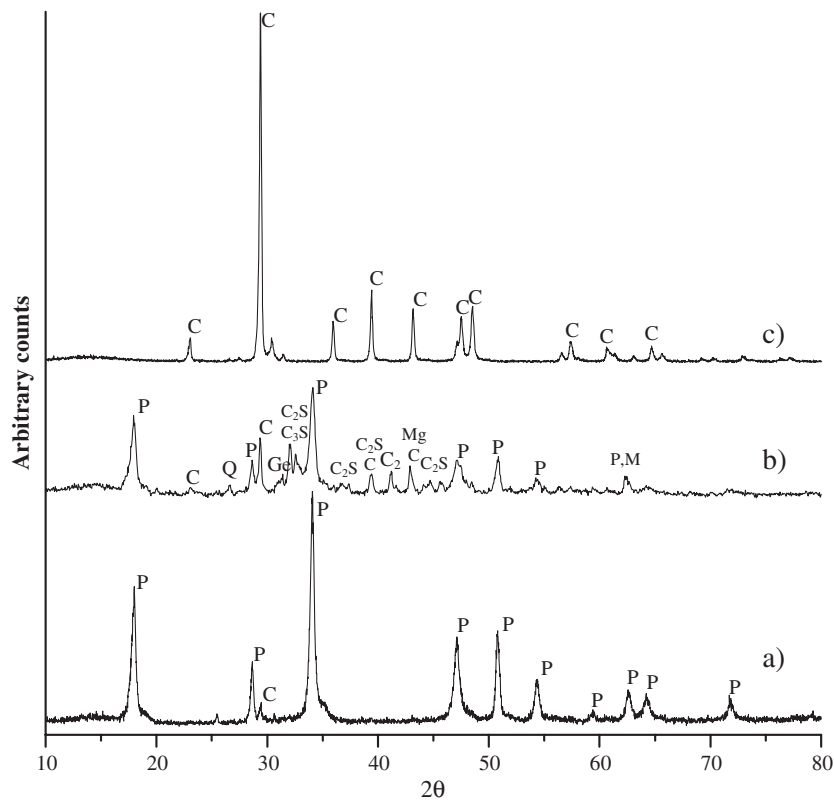
Fig. 1. XRD of (a) aerial lime; (b) natural hydraulic lime; (c) aggregate (C: Calcite (ICDD05-0586); P: Portlandite (ICDD 44-1481); C₂S: Dicalcium silicate (ICDD 02-0843); C₃S: Tricalcium silicate (ICDD 02-0849); Mg: Periclase (ICDD 45-0946); Ge: Gehlenite, C₂AS: (ICDD 35-0755); Q: Quartz (ICDD 46-1045)).

Two different kinds of limes have been used to prepare the mortars: aerial lime and natural hydraulic lime. The first one is a commercial-hydrated lime powder of the class CL90 according to the European normative [24] and was supplied by Calinsa S.A. (Navarra). The second one is a commercial lime of the class HL5 [24], and it was provided by Chau Bruyeres (Saint-Front-sur-Lémance, Fumel). Table 1 gives their chemical characterization (according to European Standard) [25] and Fig. 1 shows their X-ray diffractograms.

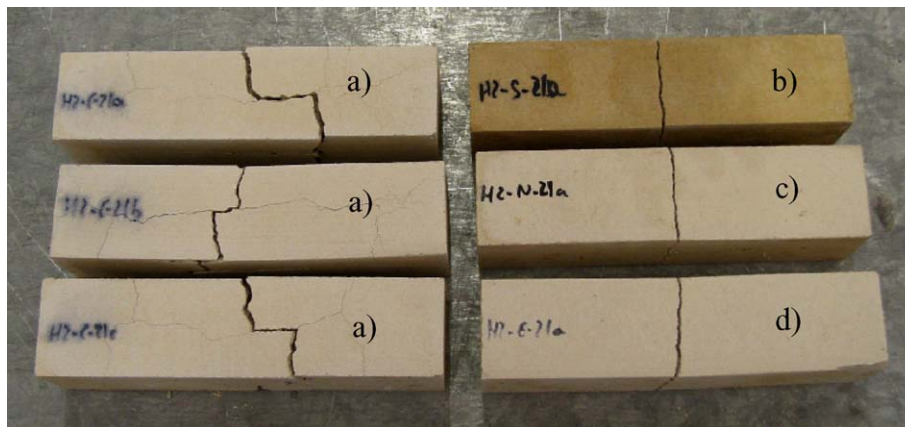
Fig. 4. Specimens after flexural determination subjected to all environments: (a) specimens tested after climatic chamber exposure; (b) SO₂ chamber; (c) indoor; (d) outside.

In climatic chamber, both flexural and compressive strengths show reduction. The mechanism of the fracture during strength determination in specimens subjected to climatic chamber is very different to the other environments. In climatic chamber exposure, the cracks generated into the specimen have been used to break it, whereas the other environments show a uniform mechanism of the fracture, as Fig. 4 presents.

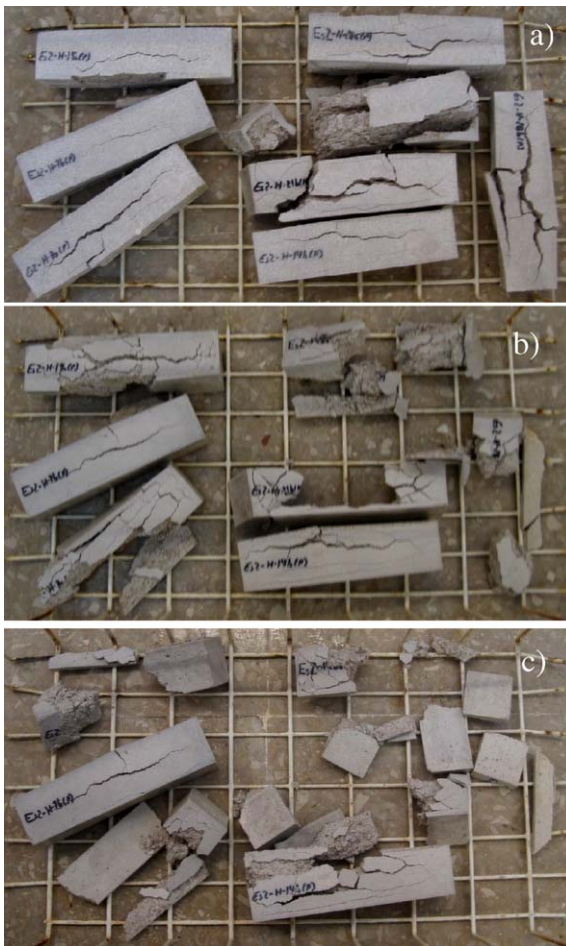
Fig. 5. Evolution of aerial lime-based mortars after: (a) 1 freezing–thawing cycle; (b) 2 cycles; (c) 3 cycles.

Aerial specimens reached a 100% of destruction after 3 cycles in F–T exposure, whereas this 100% was obtained after 7 cycles (7 test days) in climatic chamber exposure. Hydraulic specimens show a 55.6% of specimens with a degree 4 after 11 F–T cycles,

and a 33.3% in degree 4 after 28 climatic cycles (28 test days, Figs. 5 and 6, respectively).

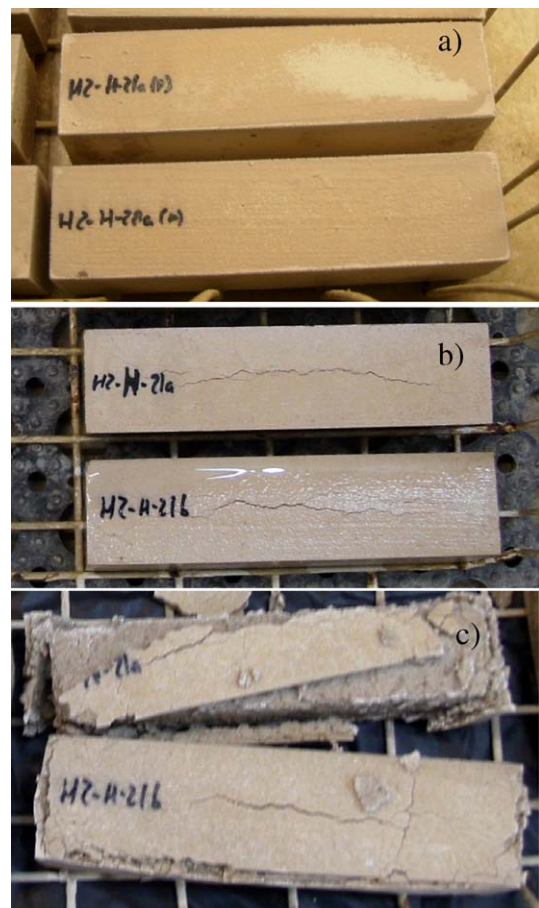
Fig. 6. Evolution of hydraulic lime-based mortars after: (a) 1 freezing–thawing cycle; (b) 3 cycles; (c) 11 cycles.

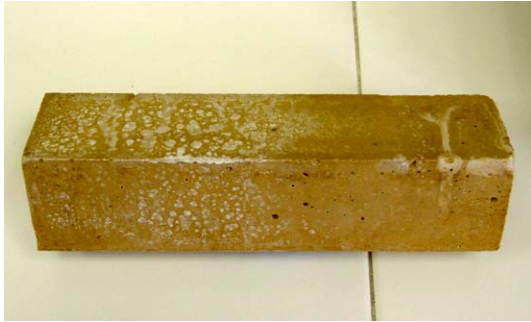
Fig. 7. SO₂ alteration in a hydraulic specimen.

SO₂-rich environment causes an alteration on the external layer of the specimens, as it has been proved by the previous analyses. Fig. 7 shows the SO₂ alteration in hydraulic specimen with white deposits on the surface of the mortar.

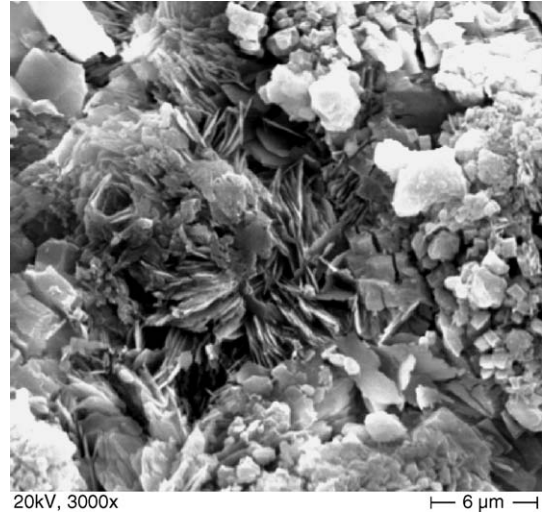
Fig. 8. Micrograph showing plate-like gypsum crystals. Aerial lime based mortar.

In SO₂-rich environment, prismatic and plate-like crystals of the gypsum were detected in aerial lime-based mortars. The whole mortar surface appears covered of gypsum, in agreement

with previous works studying the SO₂ deposition [11], giving an idea about the aggressive conditions of the attack due to the higher relative humidity and the temperature (Fig. 8).

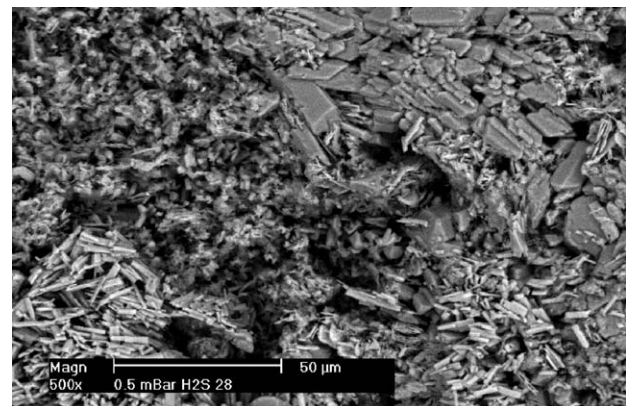
Fig. 9. Micrograph showing different areas on the surface after SO₂ attack. Hydraulic mortar.

In hydraulic specimens, SO₂ chamber exposure gives different alteration areas (Fig. 9). As Fig. 10(a) shows, large prismatic crystals similar to those in the aerial mortar have been checked. Analysis by EDS (Fig. 10(b)) indicated the presence of S, O and Ca, confirming gypsum (CaSO₄·2H₂O) formation.

Prismatic needle-shaped crystals at low magnifications (at the bottom of Fig. 9) smaller than the previously mentioned have been observed (Fig. 11(a)). In the previous work by XRD, FTIR and TG-DTA, the presence of syngenite (K₂Ca(SO₄)₂·2H₂O) in hydraulic mortars exposed to SO₂ chamber has been proved [7]. In dry conditions, the SO₂ attack gives potassium sulfate, because it has a high solubility (120 g/L). This K₂SO₄ is a kinetic product, but it has not been determined in the present wet SO₂ attack conditions: syngenite was formed in this more aggressive environment owing to its lower solubility (2.5 g/L) [11]. It is a thermodynamic control product of the deterioration by SO₂, as well as gypsum (solubility 2.4 g/L). In aerial mortars, no syngenite is detected due to the lower amount of potassium in this lime, as shown in the chemical analysis (Table 1). In agreement with the cited previous study [7], the presence of S, K and Ca has been determined by EDS analysis (Fig. 11(b)), confirming syngenite formation in these areas.

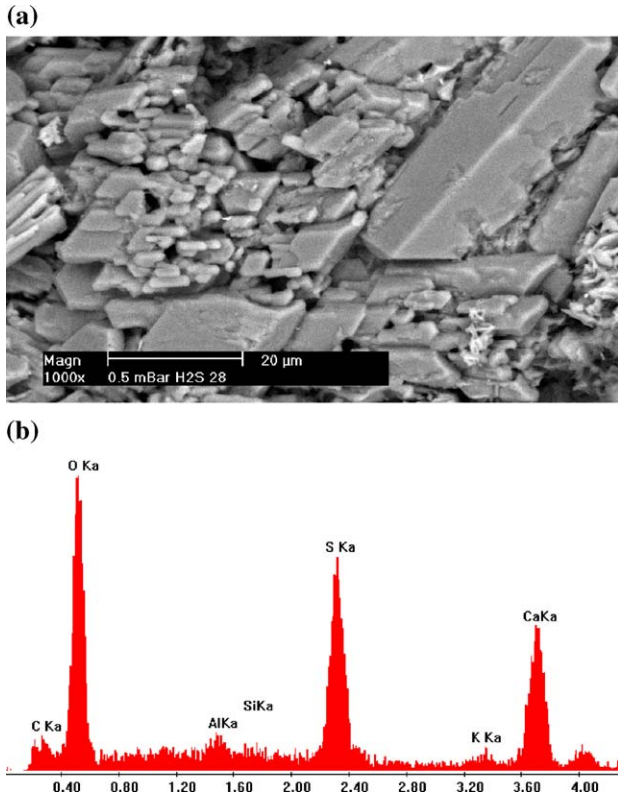
Fig. 10. (a) Magnification of large prismatic gypsum crystals. Hydraulic mortar. (b) EDAX result showing the presence of Ca, S and O.

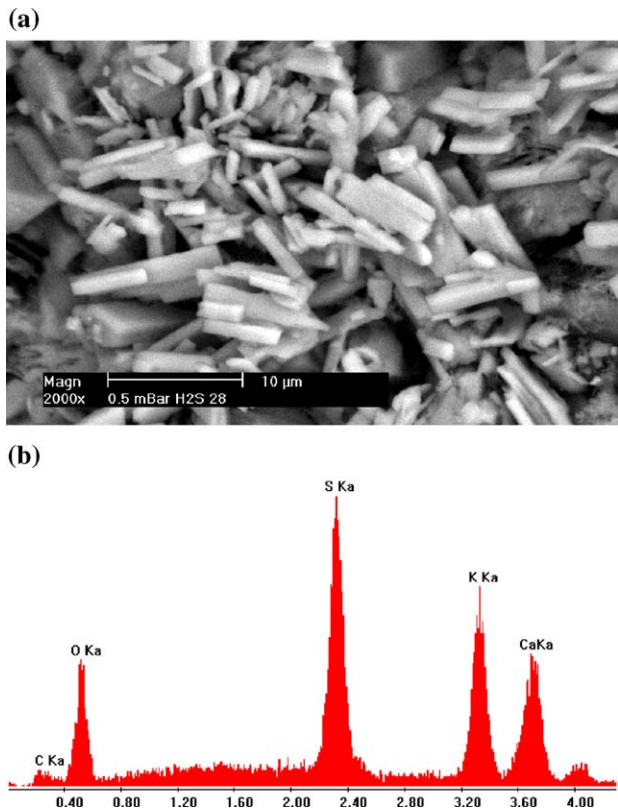
Fig. 11. (a) Magnification showing syngenite needle-shaped crystals. Hydraulic mortar. (b) EDAX result showing the presence of Ca, K, S and O.

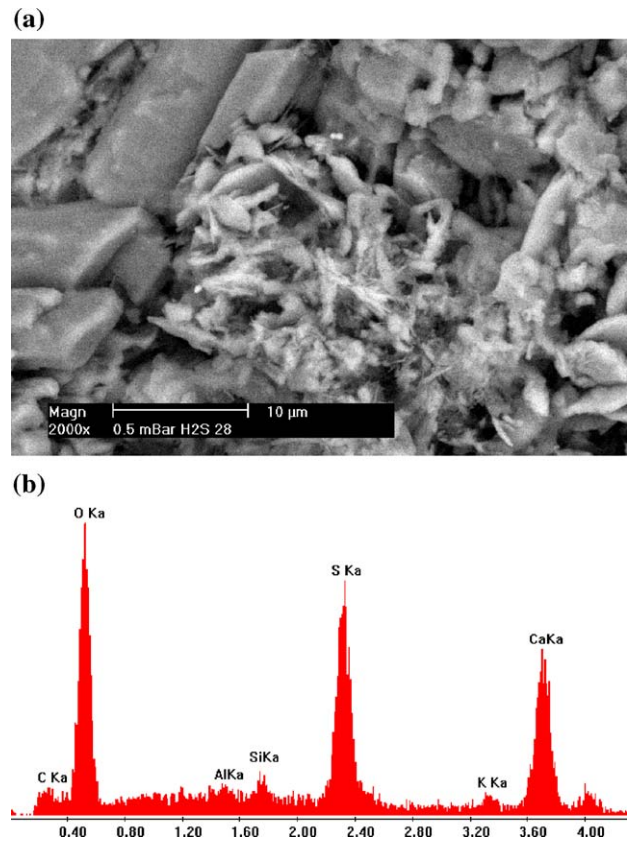
Fig. 12. (a) Micrograph showing CSH crystals close to gypsum crystals. Hydraulic specimen. (b) EDAX result showing the presence of S, O and Ca (corresponding to gypsum crystals), as well as Si and Al, attributed to CSH gel.

The CSH gel is similar to that observed in previous works [6,11]. Morphology for CSH gel (tobermorite gel) corresponds to type I-like needles (Fig. 12(a)) [11]. EDS analysis shows the main presence of gypsum crystals, as well as a little amount of Si and Al, which could correspond to CSH gel (Fig. 12(b)). It can be concluded that the product of the hydration of the hydraulic compounds has not been influenced by the presence of SO₂.
